# HOME INSPECTION SERVICES, S.C.,

December 18, 2008

RE: xxxx W. xxxxx Ave.  
xxxxxx, WI xxxxxx

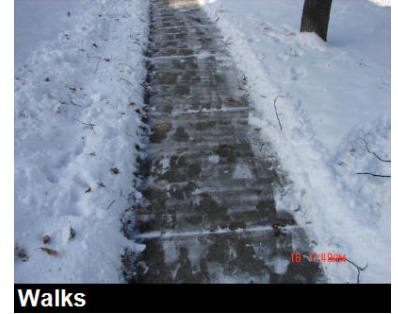
Service walk only, Cracks noted are typical, Surface raised/settled, Tripping hazards.

Hand rail suggested.

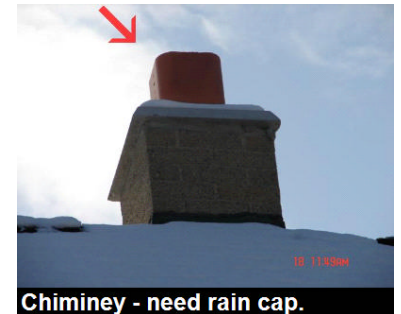
Brick materials.

The chimney cap is made of mortar. Its function is to keep water from entering the brick stack causing deterioration. This cap appears to be functioning as intended. There is no metal rain hat installed. It is recommended that one be installed to help prevent rain from entering the flue stack.

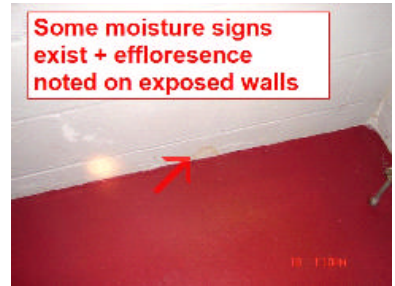
Staining was observed: Evidence of prior water penetration is noted- Seen at the east wall and south wall. Efflorescence seen on walls indicates the presence of periodic moisture.

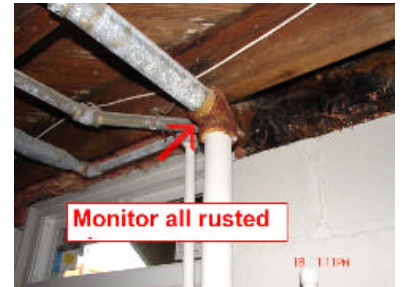
Plumbing pipes have been repaired with plastic and some piping is rusty and needs to be monitored for future leaking.

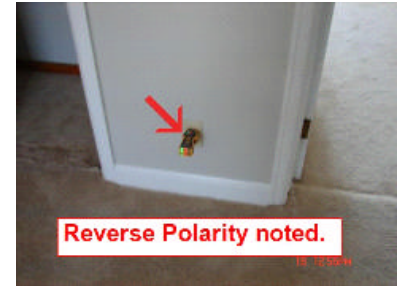
A representative sampling of switches and outlets was tested. As a whole, outlets and switches throughout the room are in serviceable condition. **Reverse polarity is noted.**

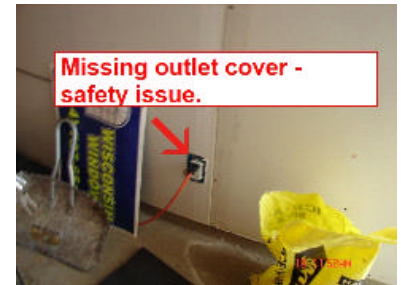
A representative sampling of switches and outlets was tested. As a whole, outlets and switches throughout the house are in serviceable condition. **Missing or damaged cover plates viewed.**

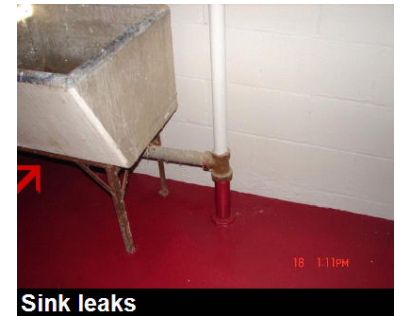
p " " " " Sink leaks - repair needed.

Sink leaks

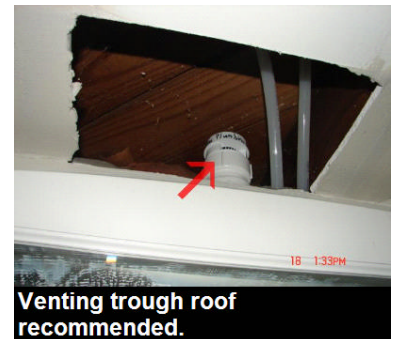
Venting should exit the side of the home.

Venting trough roof recommended.

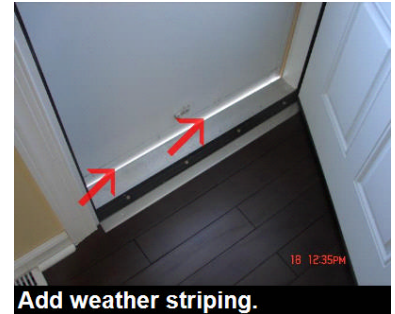
p " " " " " Add weather striping for exterior storm door.  
Hardware operational.

Add weather striping.
